## FMC KONGSBERG SUBSEA A/S

## STATOILHYDRO F4/H NORNE Field North Sea, Norway

# FINAL REPORT SUMMARY SEALMAKER SUBSEA 1/4" CONTROL LINE LEAK REPAIR

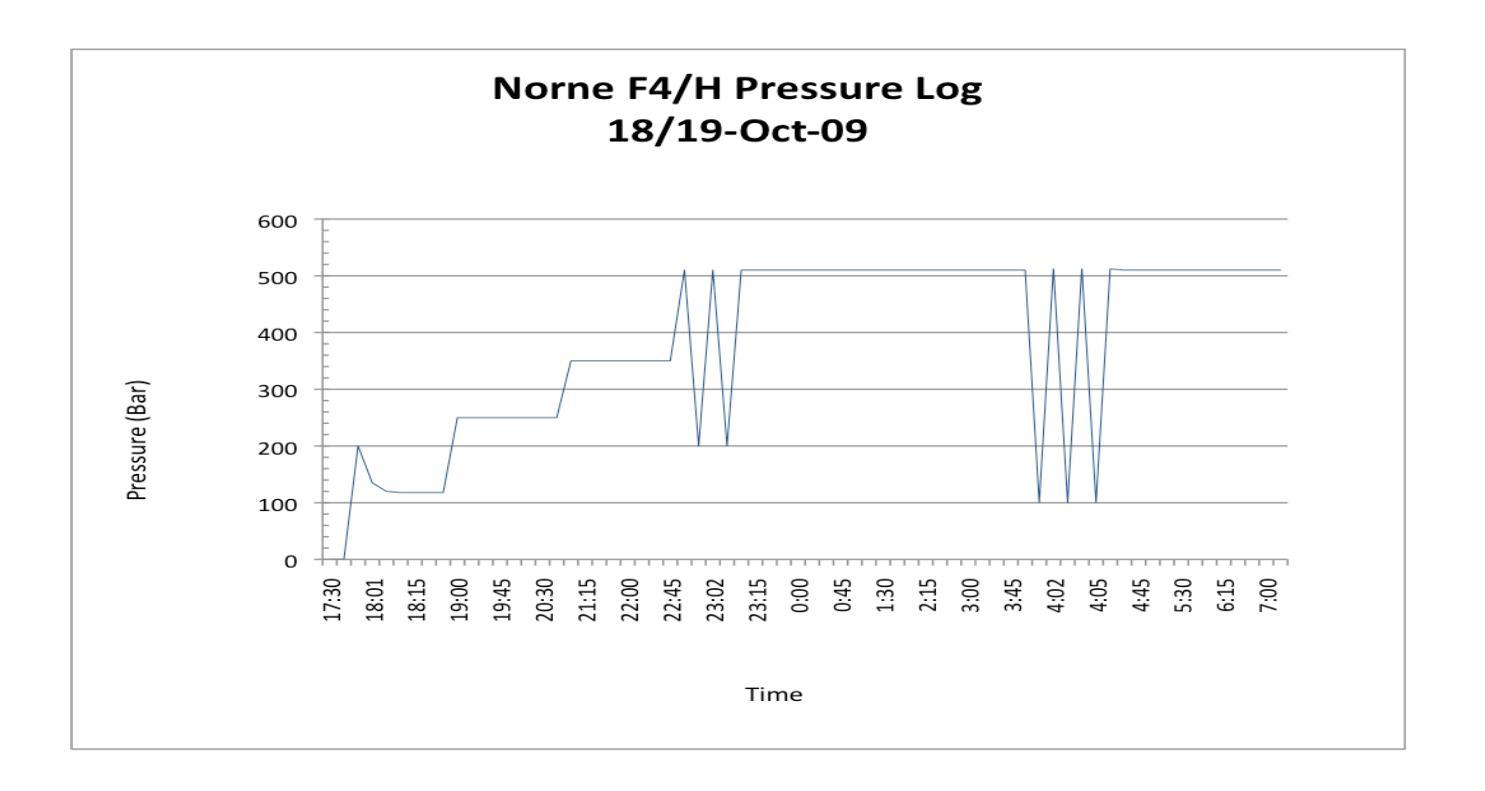
#### 4.1 **OPERATIONAL DETAILS/CHARTS**

- The leak repair was observed visually via ROV beginning at 17:45pm 18-Oct-09
- The control line leak was repaired successfully at 510 bar then flushed using pressuriztion/flowback technique and tested prior to re-installing the SCM and placing the well back in service
